Stellenbosch Municipality

Refurbishment Criteria

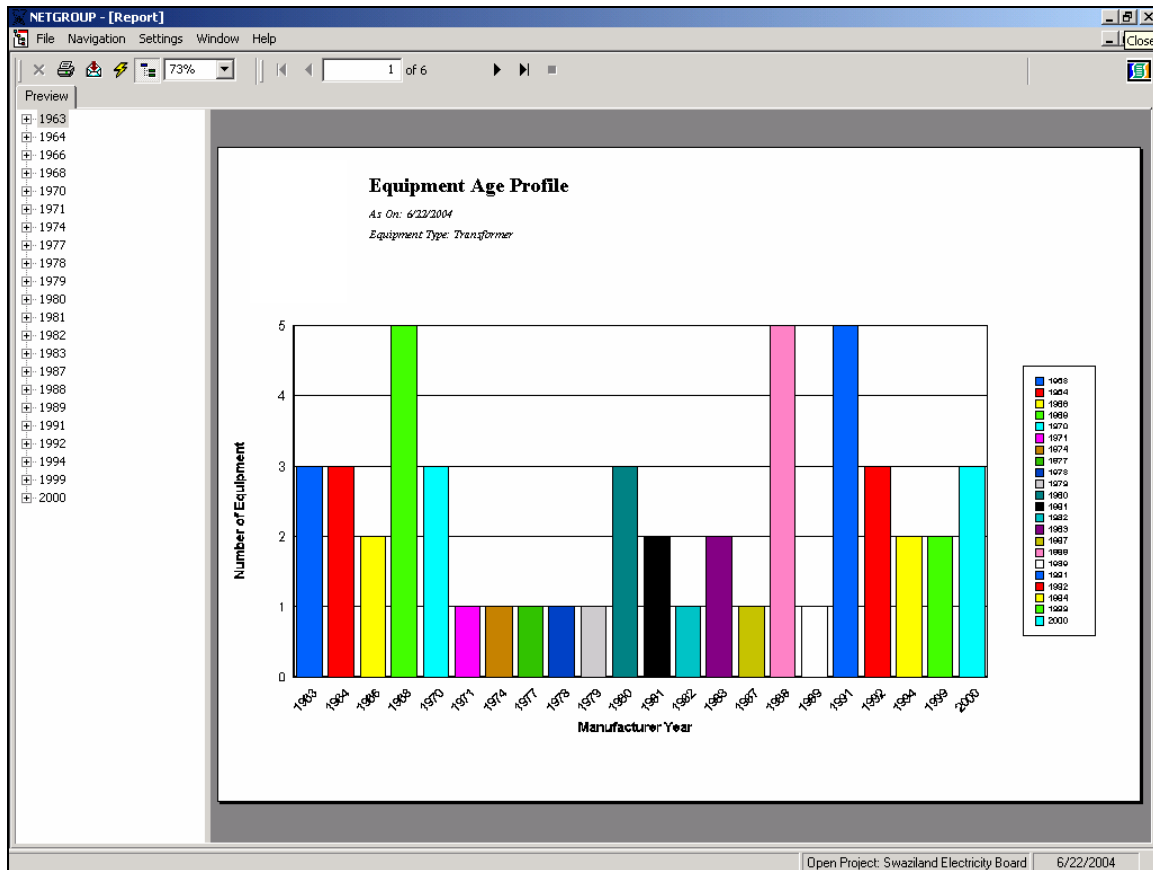
Figure 5-3: Equipment Age Profile - Transformers

Age profiles are used to highlight the following aspects:

- It provides excellent insight into the perceived state of the network,
- Identify per equipment category the expected replacement cost of assets older than a certain age,
- List and phase equipment to be refurbished or replaced in order to maintain an age of less than a specified value, and
- At what rate equipment age will increase if the current replacement or refurbishment rates are adhered to for the next 20 years.

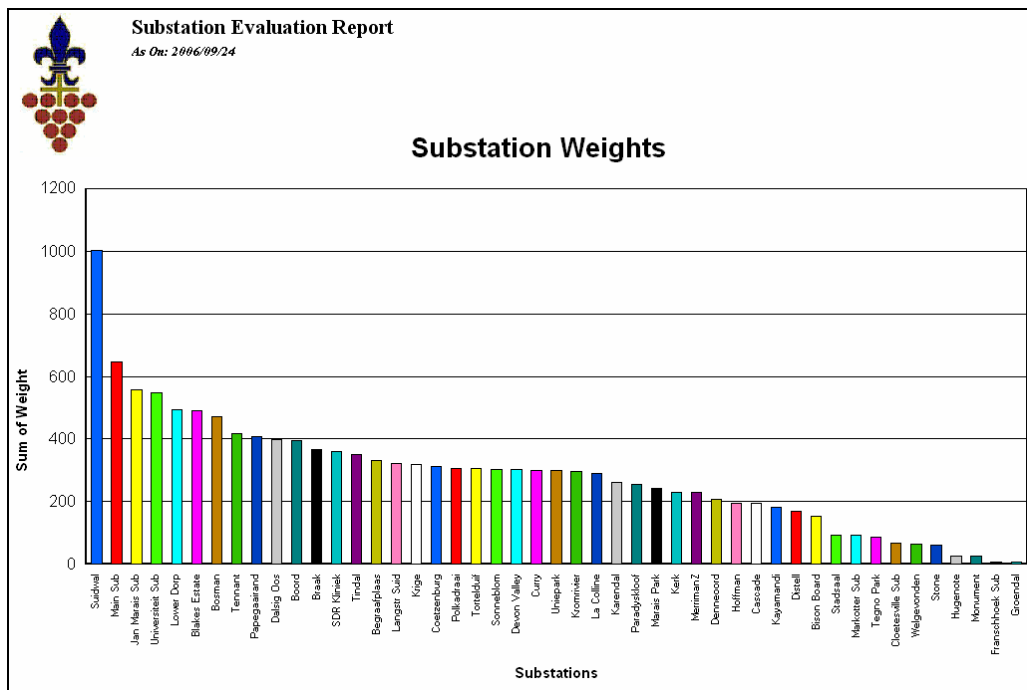
Figure 5-4: Prioritisation model

With the projects as selected in paragraph 5.6 available it is necessary to prioritise these projects before a detailed costing exercise is attempted. A prioritisation matrix needs to be compiled to be able to prioritise the selected projects. Typical indices of such a matrix are:

- Legal implications,
- Importance of customers,
- Importance of plant,
- Performance,
- Environmental aspects, and
- Future configuration of network.

These indices can be weighted in order to increase the relative importance of specific indices. Projects with life threatening and legal implications are normally of the highest priority.
