STELLENBOSCH MUNICIPALITY

**WATER DISTRIBUTION SYSTEM -
PIPE REPLACEMENT STUDY**

June 2019

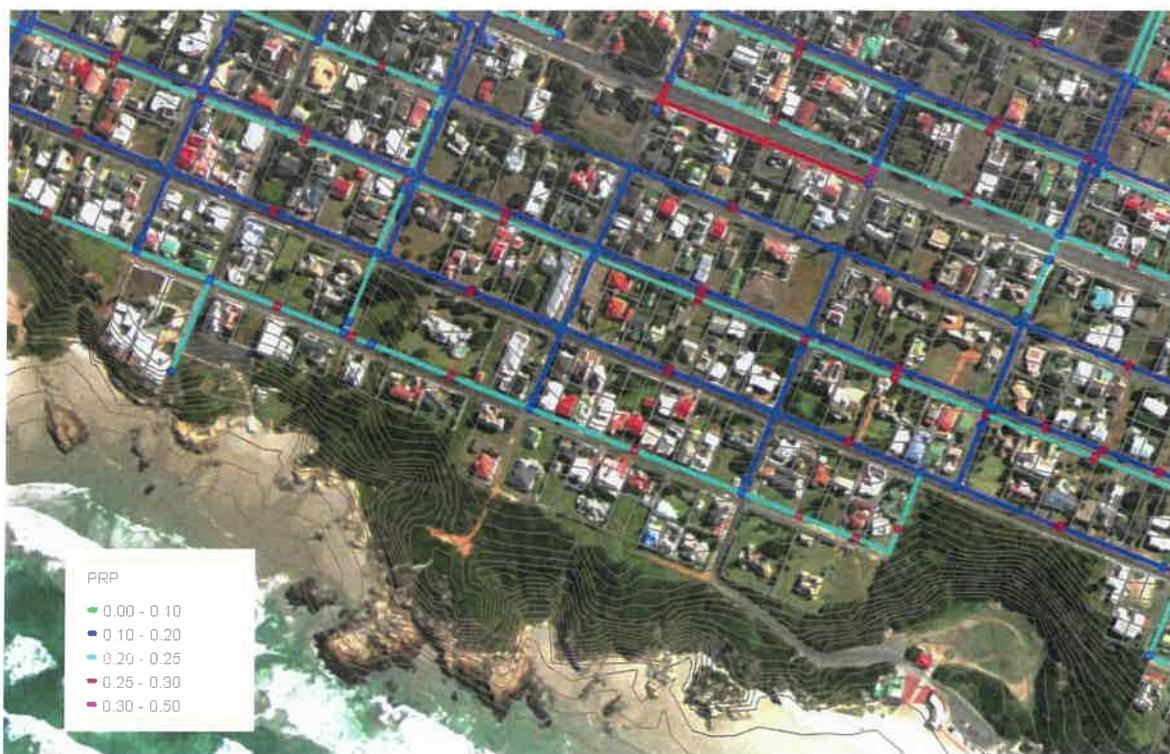
Figure 1: Graphical result where PRP is also influenced by slope analysis (on aerial image)

The *Wadiso® (GLS Software)* software has been extended to perform the required analysis. Results are then reported in the embedded GIS system per pipe and can be inspected in table or graphical format. Figure 1 shows on an aerial background image how the PRP score (as categorized in the legend) is also influenced by the slope analysis. Figure 2 shows a detailed graphical view of the same area.

It can for example be seen how the pipe highlighted in red has a number of LF and CF factors (including the location on the lower side of the road and high dynamic pressure) contributing to a relative high PRP score of 0.27. The short pipe shown in magenta has a PRP score of 0.30 mainly contributed also by its high FF and location under the tarred road.

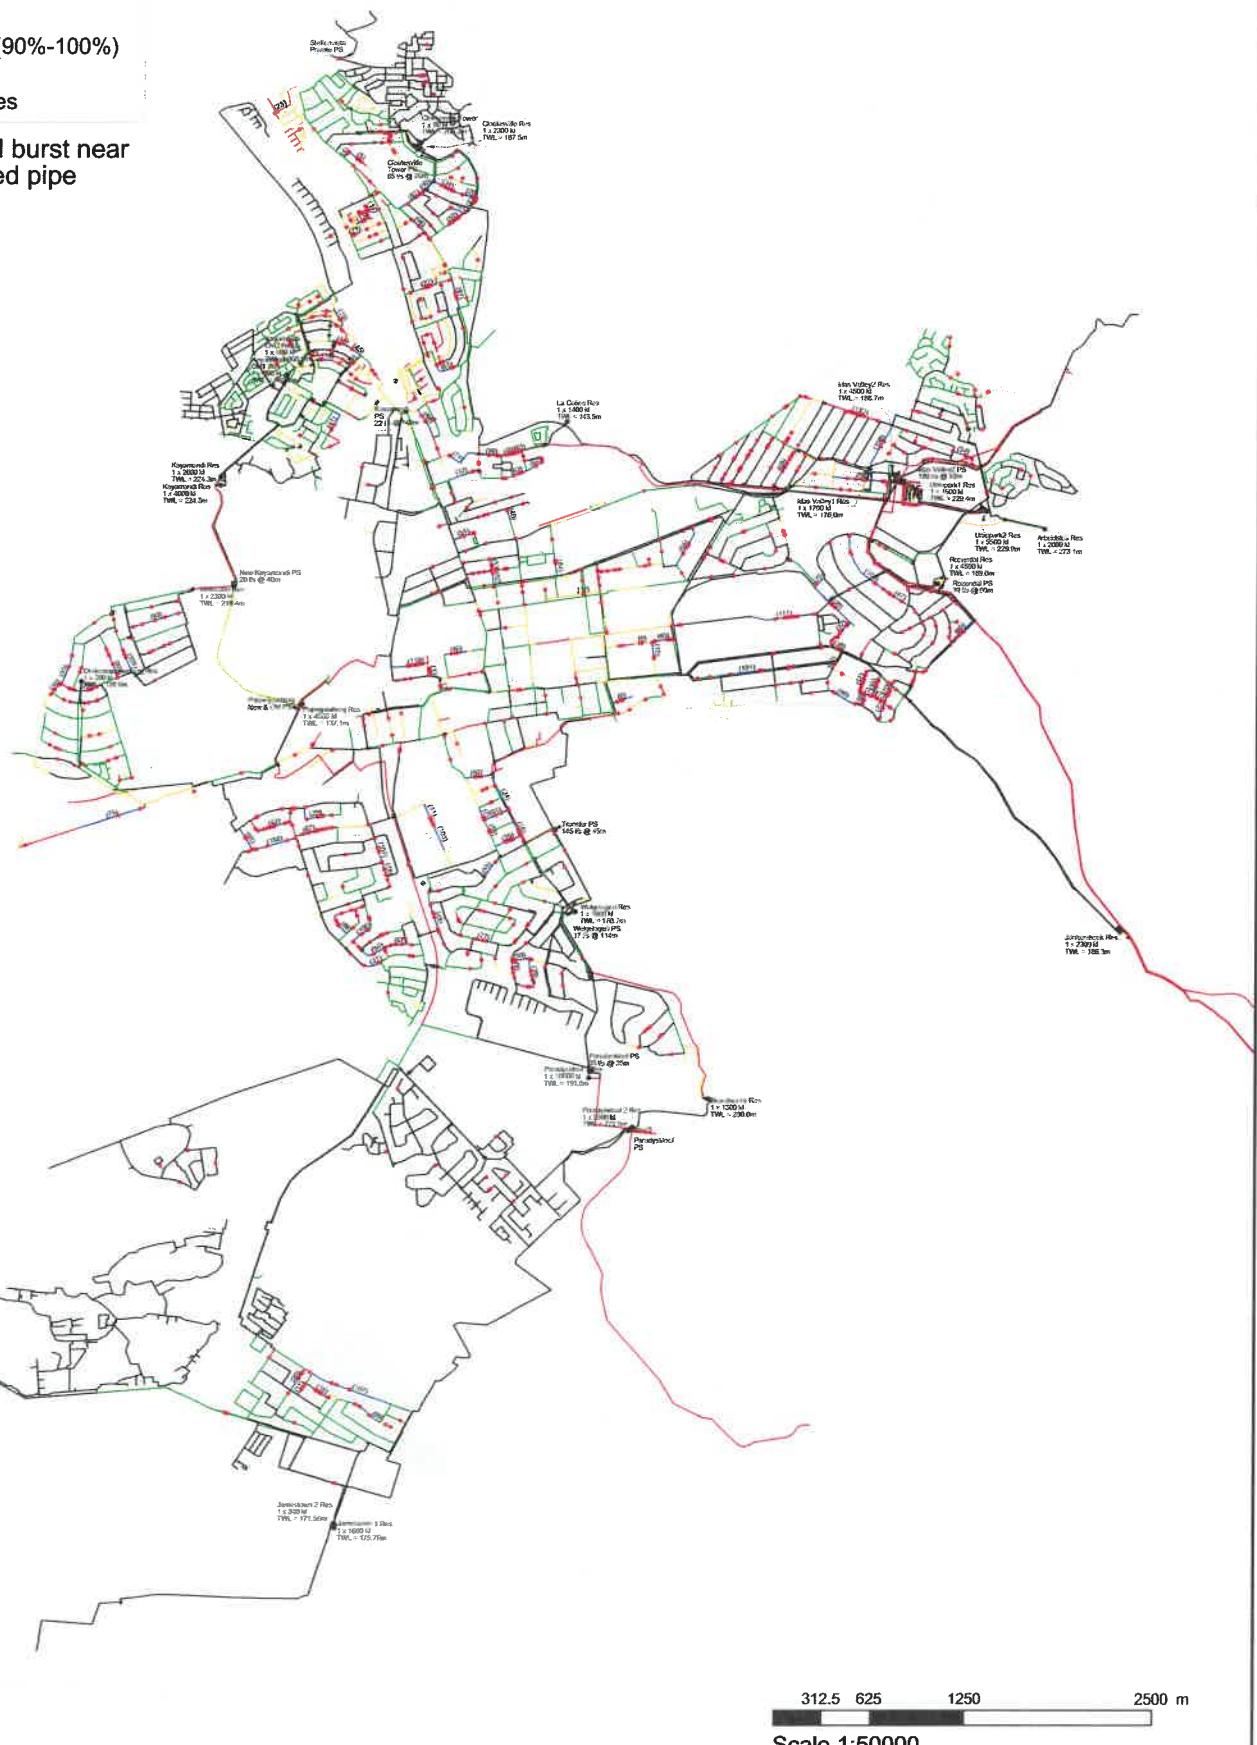
Pipe Replacement Potential

— Priority pipes

● Recorded burst near unplaced pipe

Figures SRW 1(a) to (e) show the total pipe replacement potential (PRP%) for each pipe in the model categorised as low (<60%), average (60%-80%), high (80%-90%) and very high (>90%). The higher the value, the higher the potential for replacement. Where a failure location is related to a pipe that has been replaced since the failure date, the location has been excluded from the map and deemed outdated.

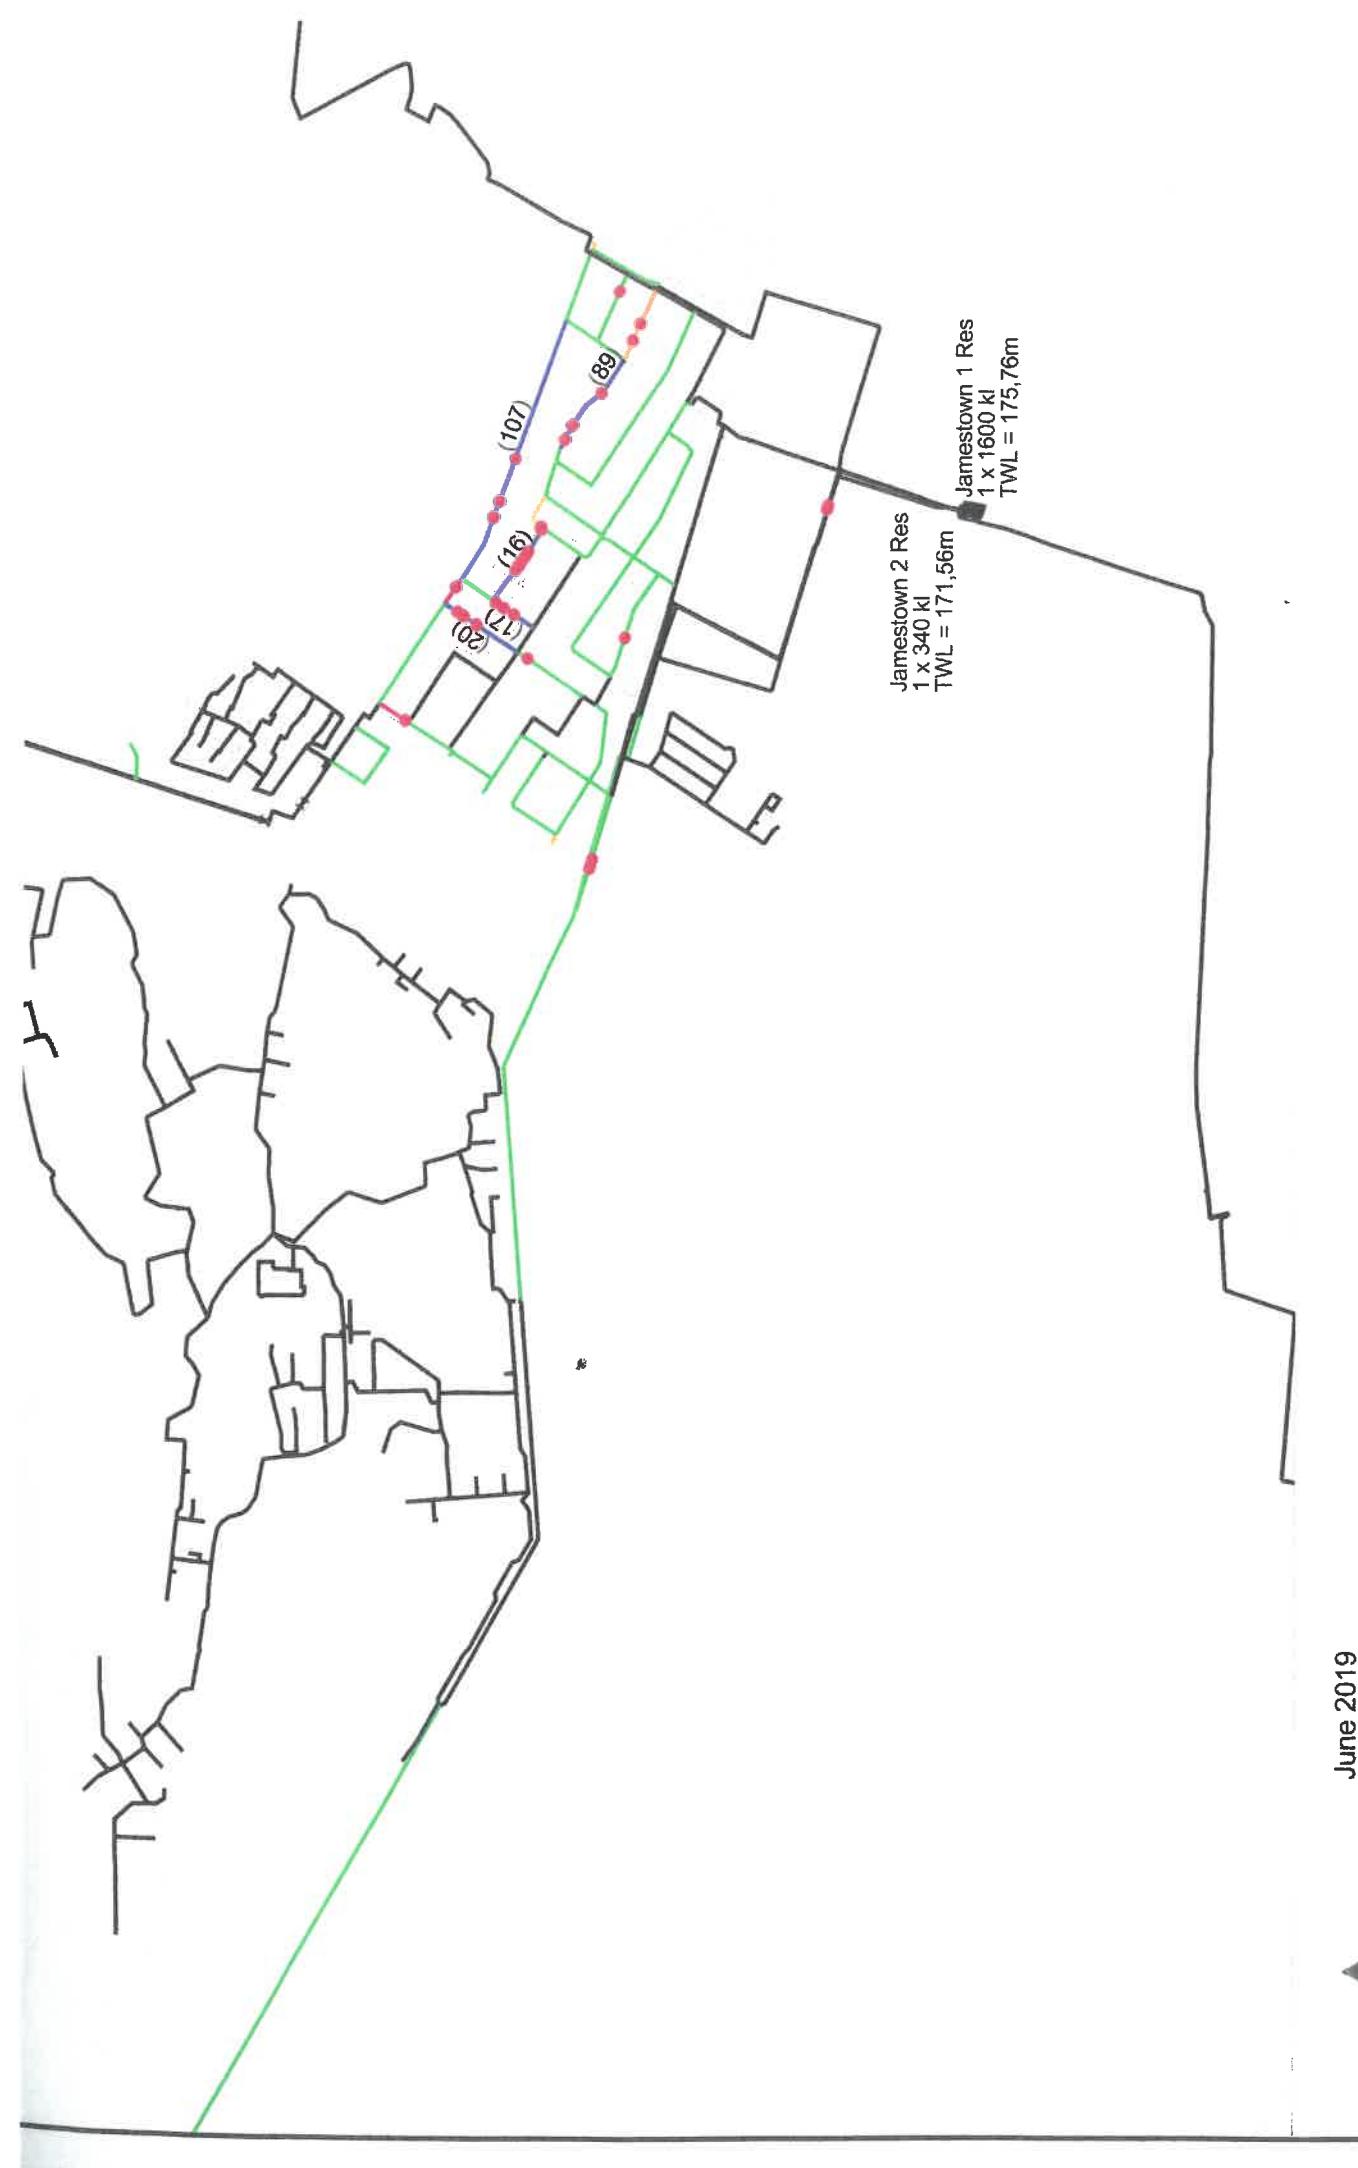
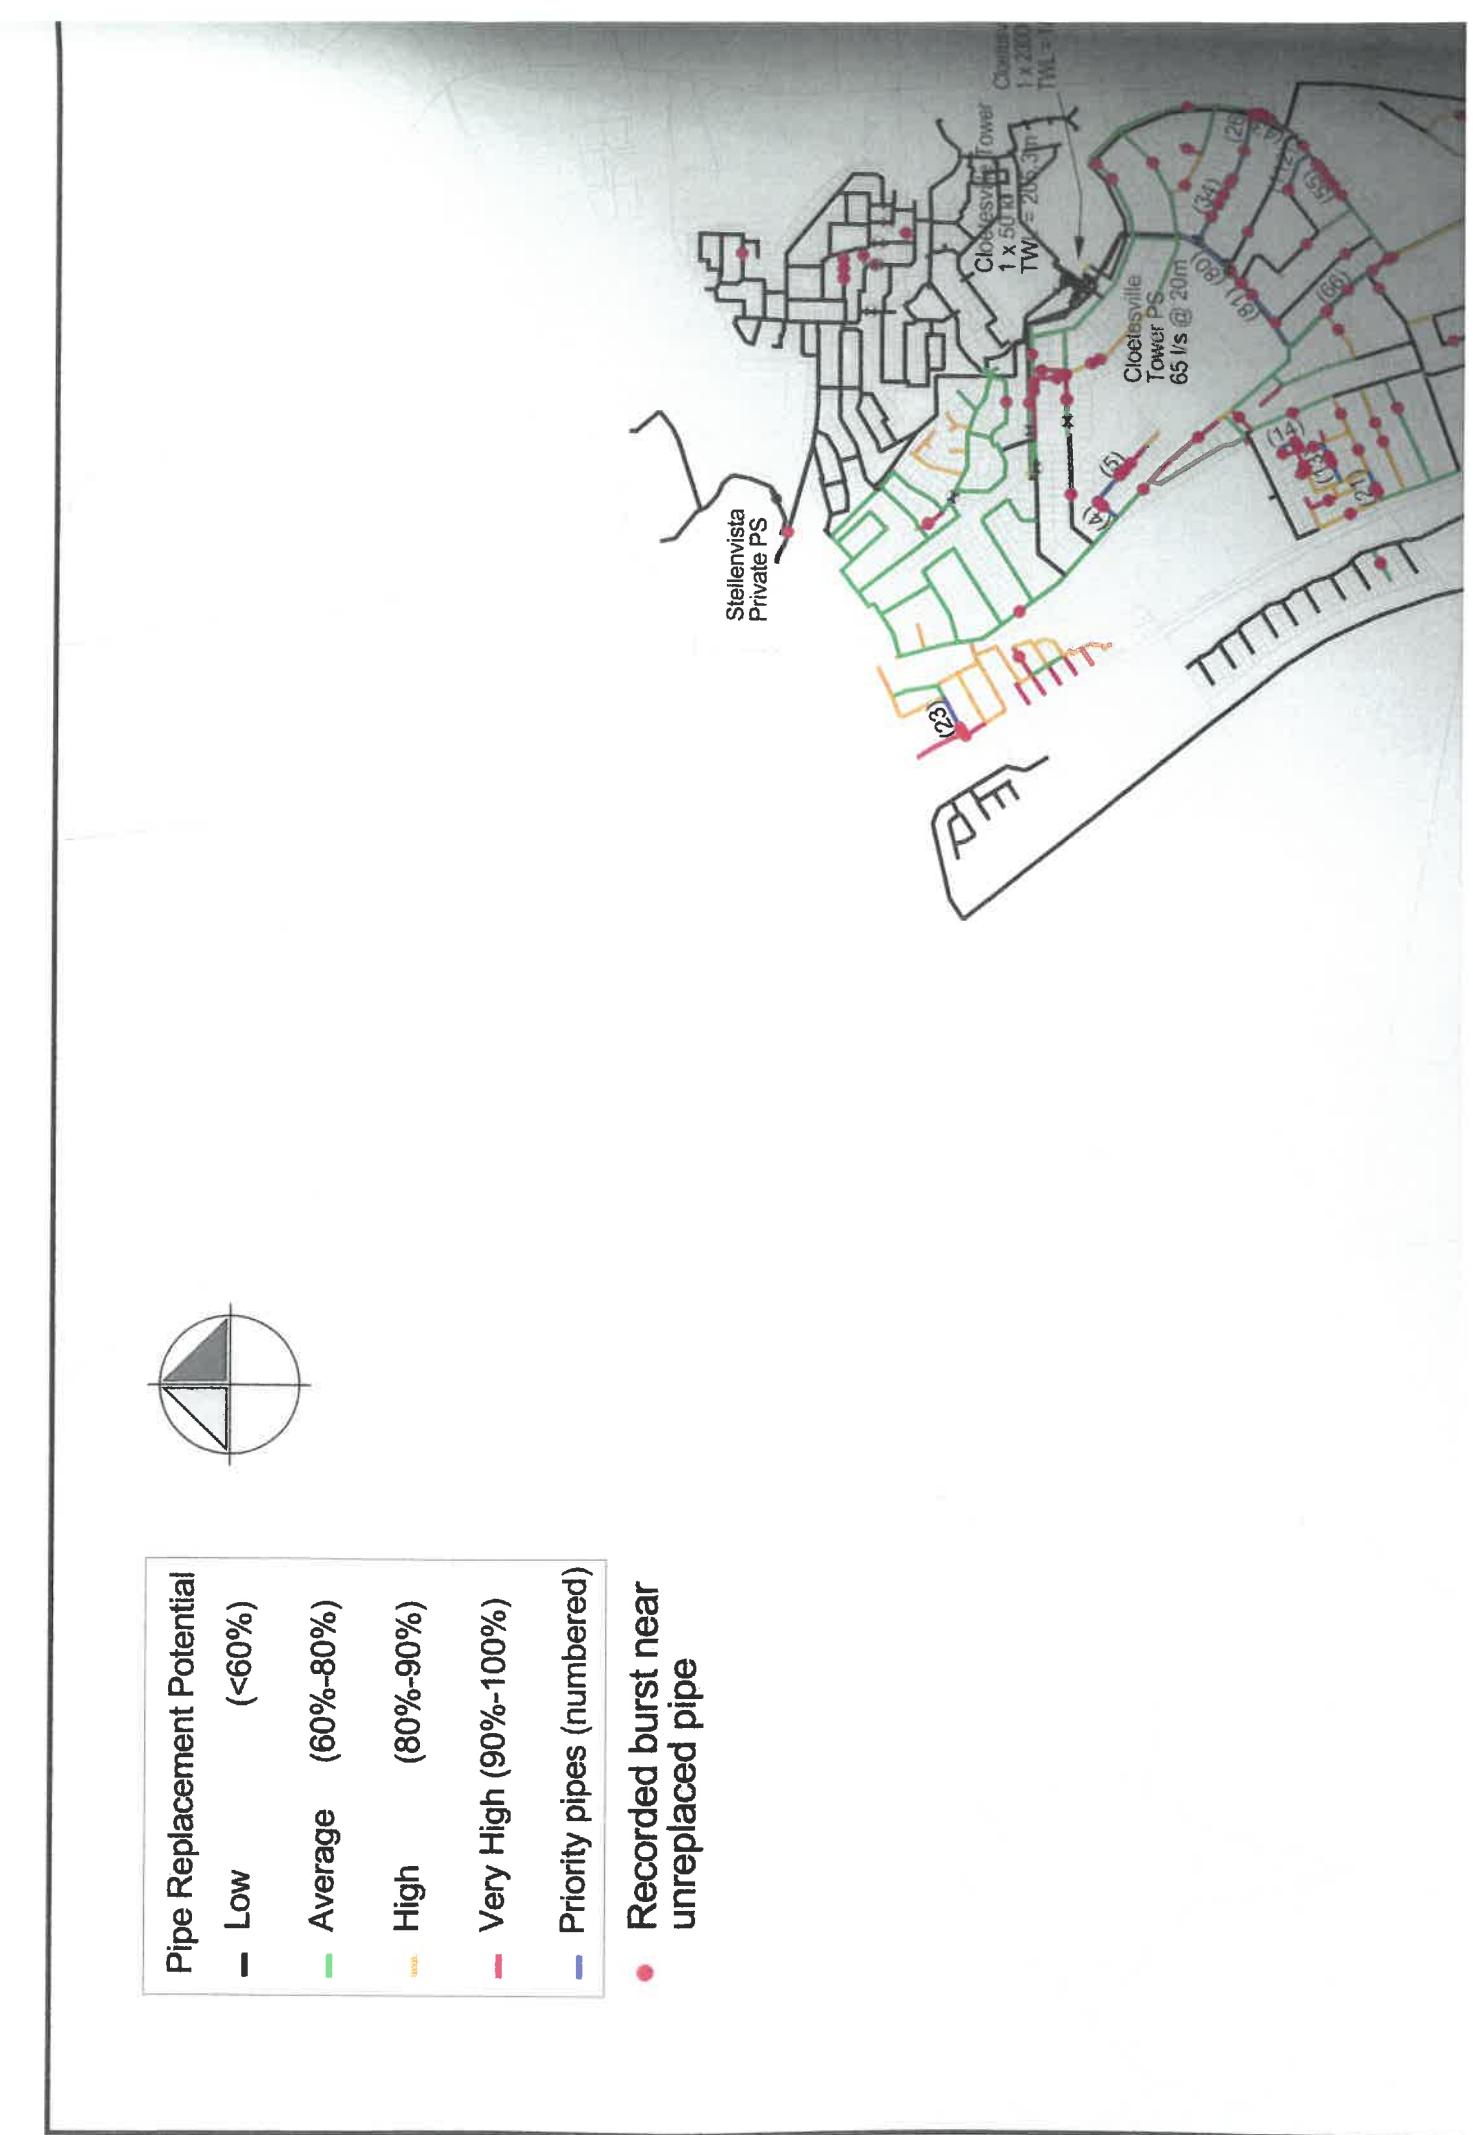
Pipe Replacement Potential	
—	Low (<60%)
—	Average (60%-80%)
—	High (80%-90%)
—	Very High (90%-100%)
—	Priority pipes (numbered)

- Recorded burst near unreplaced pipe
