**TENDER NO.: B/SM 32/26**  
**UPGRADING OF 146 MUNICIPAL RENTAL FLATS IN KAYAMANDI,**  
**STELLENBOSCH**  
**PROCUREMENT DOCUMENT**

TENDER NUMBER: **B/SM 32/26**  
DESCRIPTION: UPGRADING OF 146 MUNICIPAL RENTAL FLATS IN KAYAMANDI, STELLENBOSCH  
CLOSING DATE: 08 December 2025  
CLOSING TIME: 12h00: Bids will be opened in the **Council Chambers or Supply Chain Management Boardroom**.  
CIDB: The following CIDB class of construction works will be applicable to the Tender, in accordance with the sum tendered or value determined in accordance with regulation 25(7A) of the Construction Industry Development Regulations, 2004 (as amended) – As of 23 May 2019 - Class of Construction Works: CIDB grading of 6GB or higher is required

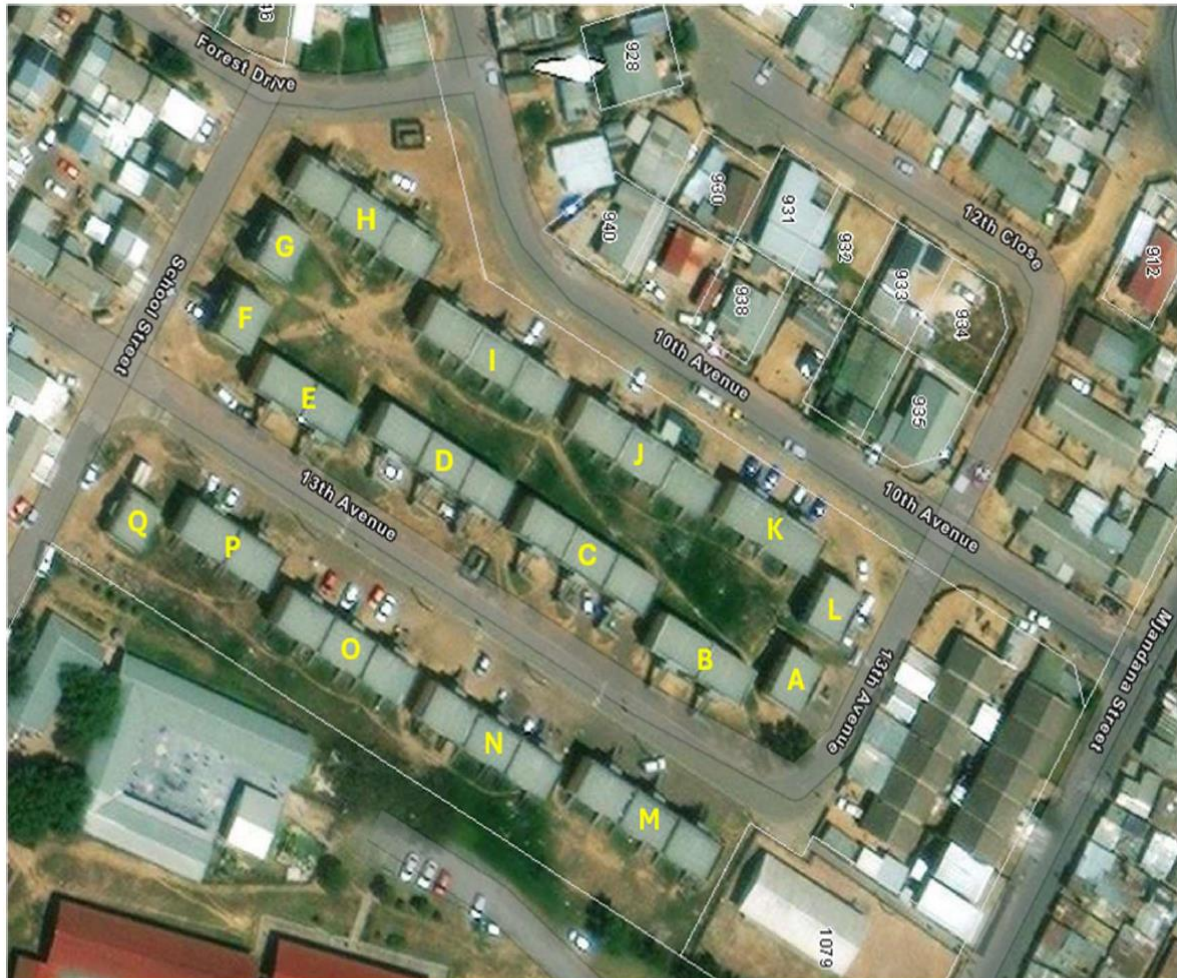
Figure 1: Housing Units Block Layout

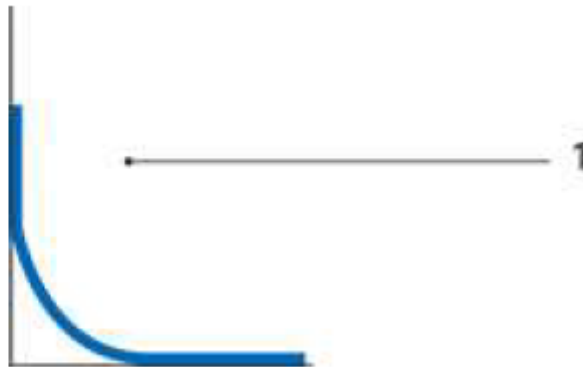
*Figure 5: Min height of 100mm*

- A sand/cement cove with a 35mm radius is to be formed at all internal angles.
- The surface to receive the Derbigum or similar approved (please provide specifications sheet for similar approved product) is to be fully primed with a bitumen primer.

Derbigum or similar approved (please provide specifications sheet for similar approved product) is sealed by 'torch-on' fusion over the cove and to the vertical surface to a minimum height of 100mm. (Figure 5 above)
